# Agilent HPLC System Firmware Bulletin

## Firmware Set A/B.06.10

Edition 04/29/2014

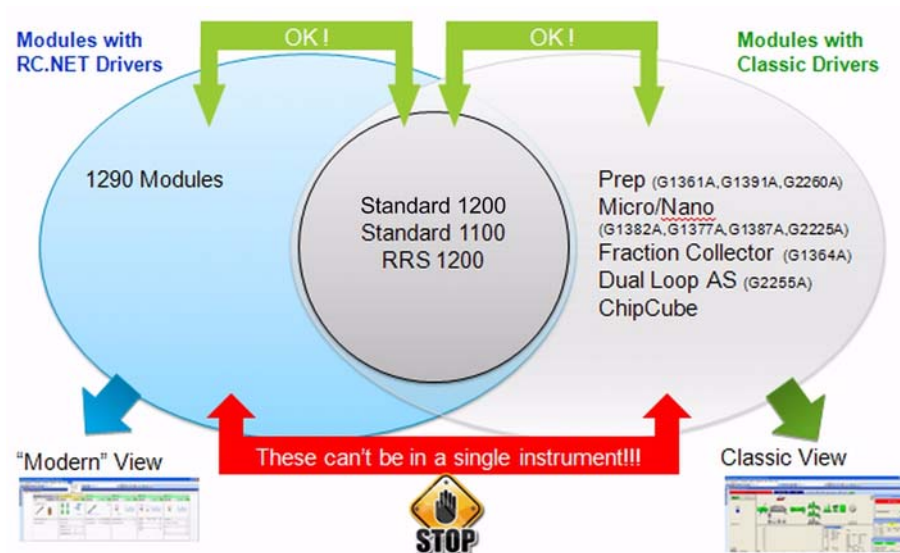
**Figure 1** Agilent ChemStation B.04.02 vs. 1290 and 1100/1200 modules

Due to a new driver concept the initial Agilent ChemStation B.04.02 release does not support all combinations of 1290 Infinity LC System with 1100/1200 modules, see [Figure 1](#) on page 88.

For a complete compatibility matrix contact your local Agilent ChemStation Support.
